Meeting the Challenge of Pipeline Emergency Repair

ABSTRACTS

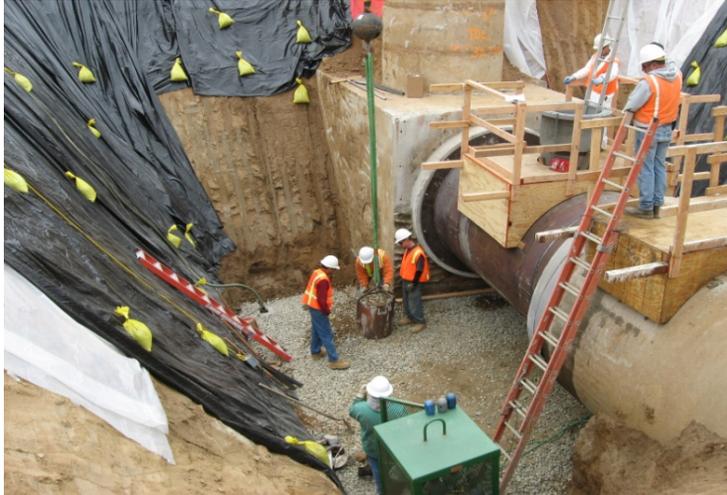
Figure 1 - PCCP Replaced with Steel Pipe

If the distressed PCCP pipe is located in a rural area where an open cut excavation is possible, the pipe will be excavated to the bottom of the pipe. The distressed pipe will be completely removed (from joint to joint) and replaced with an equivalent length and diameter of steel pipe. The connection between the PCCP and steel pipe will be encased in concrete to provide a transition from rigid pipe to flexible pipe. The excavation does not need to be fully backfilled before the pipeline can be returned to service.

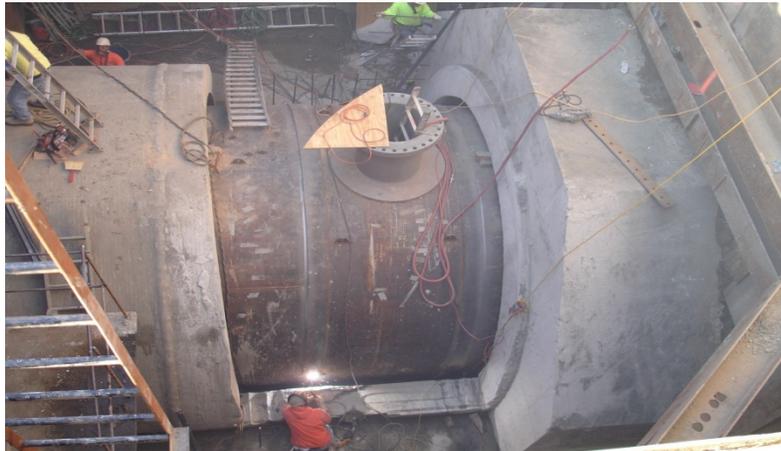
Figure 2 - PCCP Repair with Steel Liner

If the distressed pipe is located in an urban area where an open cut excavation is not feasible, shoring will be required for excavation. This can be challenging especially when the soil cover is deep and the pipe diameter is large. To reduce the excavation and shoring installation effort, the pipe can be exposed to just below the springline. A portion of the upper half of the distressed pipe will be cut off and removed, then a few steel segments with a slightly smaller diameter than the PCCP, will be inserted into the PCCP and connected together by welding. End rings between the bell and spigot and the liner prevent water from getting behind the liner. The annular space between the PCCP and steel liner will be filled with cement grout to provide support to the steel liner. The pipeline can be returned to service once the grout reaches the minimum required strength.

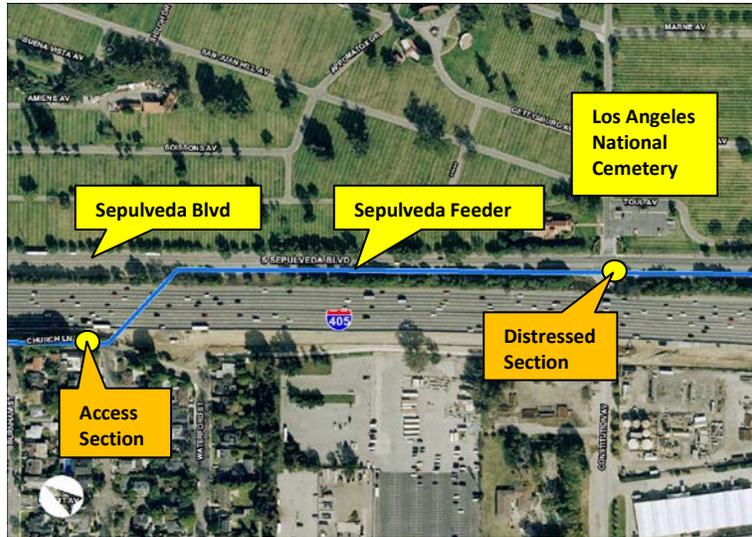
Figure 3 - PCCP Repair via Remote Access Point

When excavation around the distressed pipe is not feasible but a nearby location can be excavated, a PCCP segment at the nearby location will be identified for excavation. The excavation can be either full or half depth of the pipe as shown in Figures 1 and 2. A few smaller diameter, short length segments of steel liner will be inserted into the PCCP and transported to the location where the distressed PCCP is

located and connected together by welding. The diameter and length of the steel liner segment need to be carefully determined to allow the steel liner to be transported through horizontal or vertical bends. The PCCP that is cut off for access will be repaired with either a steel pipe or steel liner as described above. This method can also be used when multiple adjacent pipe segments need to be repaired.

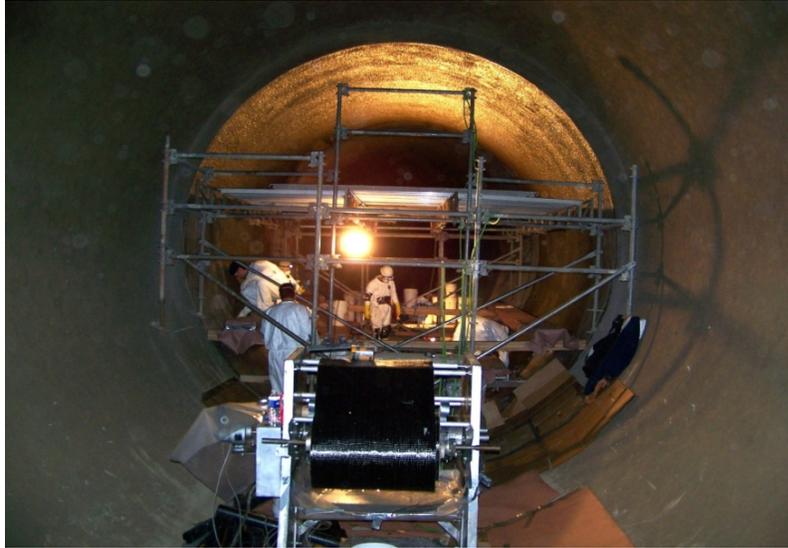
Figure 4 - PCCP Repair with CFRP Liner

When excavation around or nearby the distressed pipe is not feasible, Carbon Fiber Reinforced Polymer (CFRP) liner will be installed to strengthen the distressed pipe. The advantage of this repair method is that no excavation is required because all the repair activities can be performed by access the pipe through an existing manhole. Permitting and planning requirements are usually minimum, therefore the repair can be done quickly. This repair method involves installing a number of layers of CFRP laminates onto the interior surface of the distressed PCCP to provide structural strength for the pipe to resist internal and external loads. The ends of the CFRP liner need to be carefully terminated and sealed to prevent water from getting behind the CFRP liner.

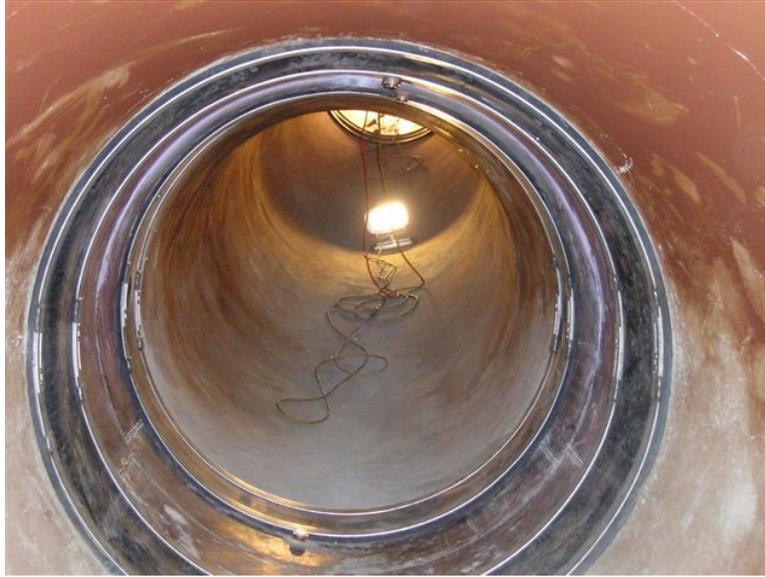
Figure 5 – Concrete Pipe Repair with Internal Seal

Most of the problems MWD has experienced in this type of pipe are water leaks at pipe joints or at circumferential crack which do not require structural repair. One effective repair method is to install an internal EPDM seal with steel retaining bands to cover the leaking joint or crack if the pipe interior is circular and uniform. If the pipe interior is non-circular, such as a transition from circular to rectangular shape, or non-uniform in size, such as a transition for different pipe diameters, EPDM seal with steel retaining bands will not be effective. In this case, a Fiber Reinforced Polymer (FRP) lining can be installed across the joint or crack. The installation is similar to CFRP liner but only a few layers are needed because no structural strengthening is required in this case.

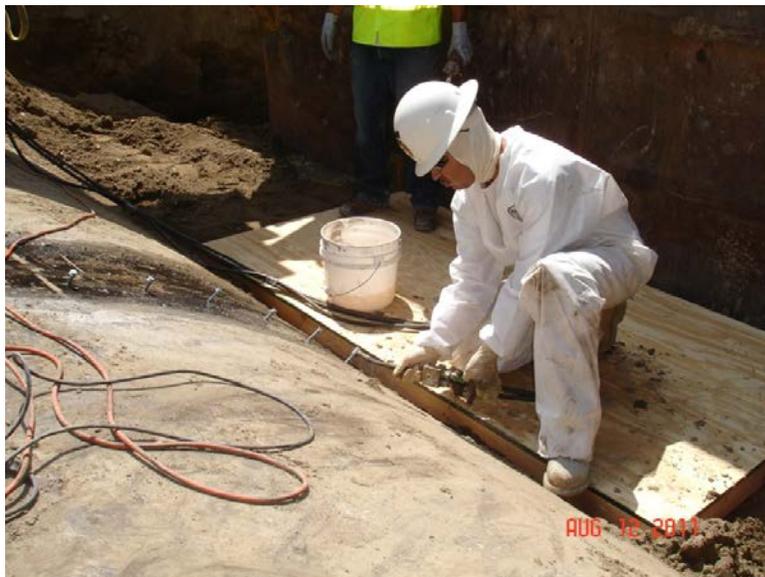
Figure 6 – Concrete Pipe Repair with External Injection

Installing EPDM seal or FRP lining require a shutdown and dewatering the pipeline. However, if the pipeline cannot be shutdown due to operational reasons, an attempt has to be made to seal the leak while the pipeline is under operation. This can be done effectively on very low pressure pipe by injecting sealing material into the leaking joint or crack from outside of the pipe. When the water pressure is high, there are significant challenges to inject sealant material against the water pressure and hold it in place gel so it is not pushed out by leaking water.

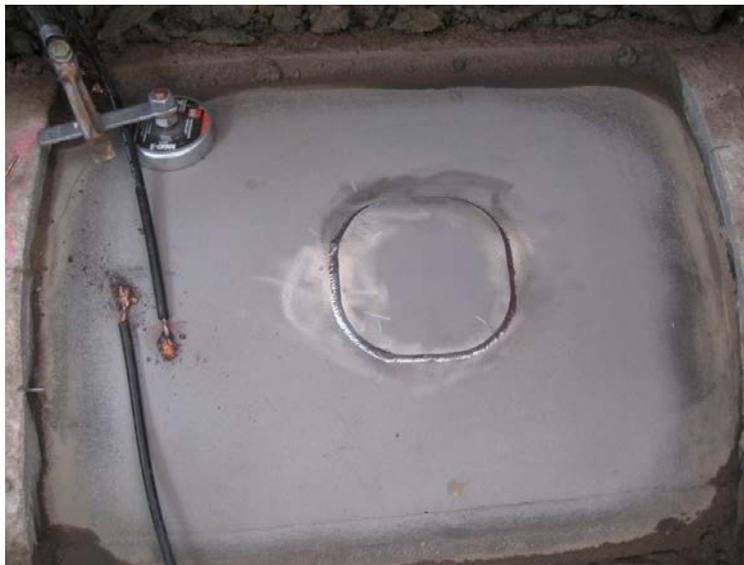
Figure 7 – Steel Pipe Repair with Steel Patch

If the leak is at an isolated spot and the surrounding material is structurally sound, a properly sized steel patch can be welded onto the pipe to cover the defected area, either internally or externally. Precautionary measures shall be used to prevent overheating the pipe and damaging the existing lining or coating when performing welding. Removed lining or coating needs to be repaired after welding.

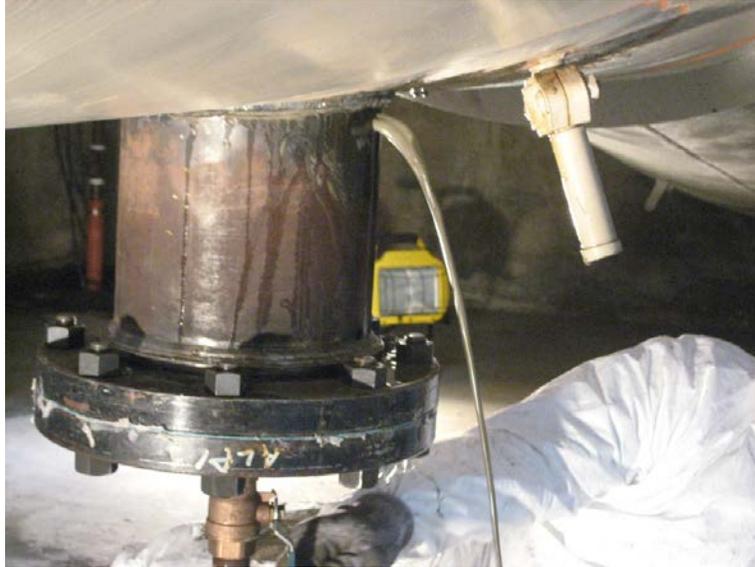
Figure 8 – Steel Pipe Repair with Steel Outlet

Another repair option is to weld on a steel outlet with blind flange. The outlet can be welded to the steel pipe over the leaking area. Precautionary measures shall be used not to overheat the pipe and damage the interior lining when performing welding. If the pipe can't be shutdown then a small valve can be installed on the blind flange to allow water to drain out while welding on the outlet. The outlet can then be filled cement grout.

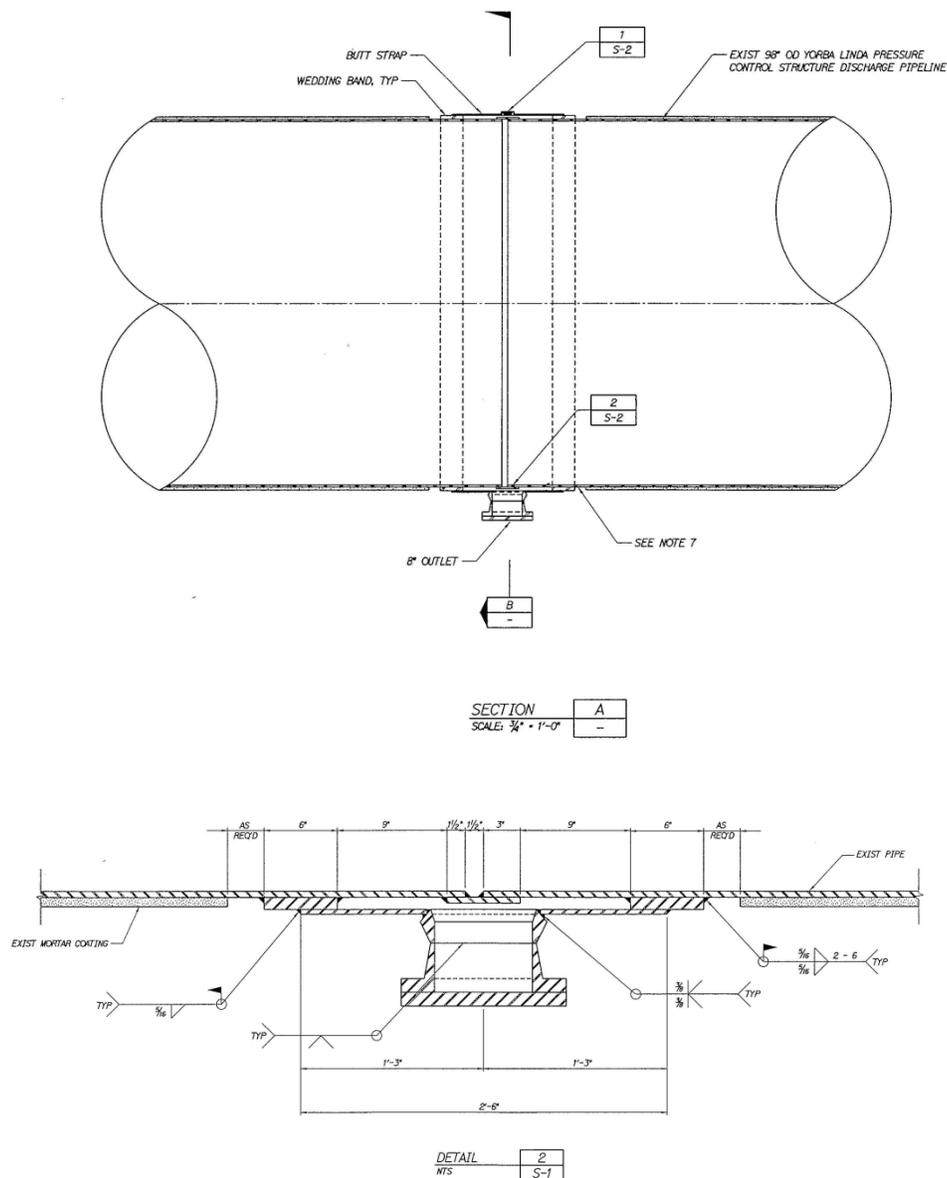
Figure 9 – Steel Pipe Repair with External Steel Band

If the leak is a crack at a pipe joint, an internal steel band can be installed at the pipe joint to cover the crack if the pipeline can be shut down for repair. Internal steel band can be fabricated from a few short pieces steel. These pieces are then brought into the pipe through an existing manhole. The steel band pieces are welded together inside the pipe. If the pipe cannot be shut down for repair but excavating the pipe is possible, a steel band can be installed from outside of the pipe while the pipe is under operation. The pipe has to be properly supported when exposed for such repair.
