Causes of Etiwanda Pipeline Lining Failure

By: Mike McReynolds, S.E. P.E.⁽¹⁾, Tao Peng, S.E., P.E.⁽²⁾, and
Andrew Romer P.E. M.ASCE⁽³⁾

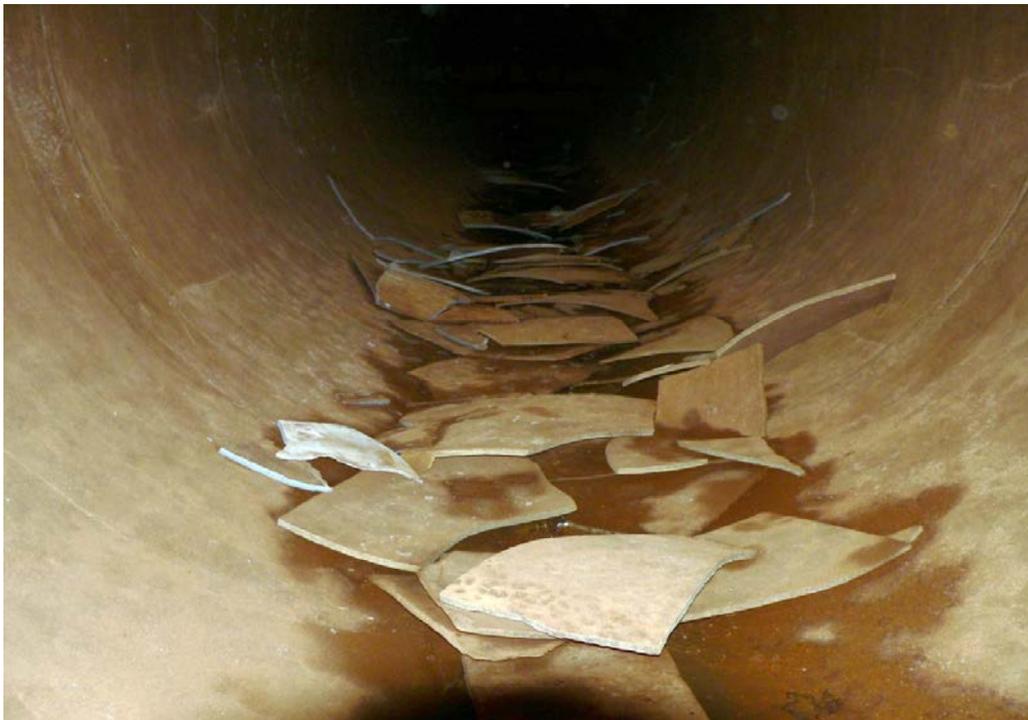
Typical Mortar Lining Failure Inside Etiwanda Pipeline.

- 245 locations with missing and delaminated mortar lining that ranged from 1 foot to 400 feet in length and an affected area varying from 1 ft² to 7500 ft².
- Approximately 37% of the 5.3 mile inspected length had missing or delaminated mortar.
- Most of the missing or delaminated mortar was in the top half of the pipe surrounding the crown.
- Most of the non-delaminated lining had several longitudinal cracks around the circumference, with a higher concentration of longitudinal cracks near the crown.
- In areas where the mortar was missing or delaminated the steel appeared heavily corroded.

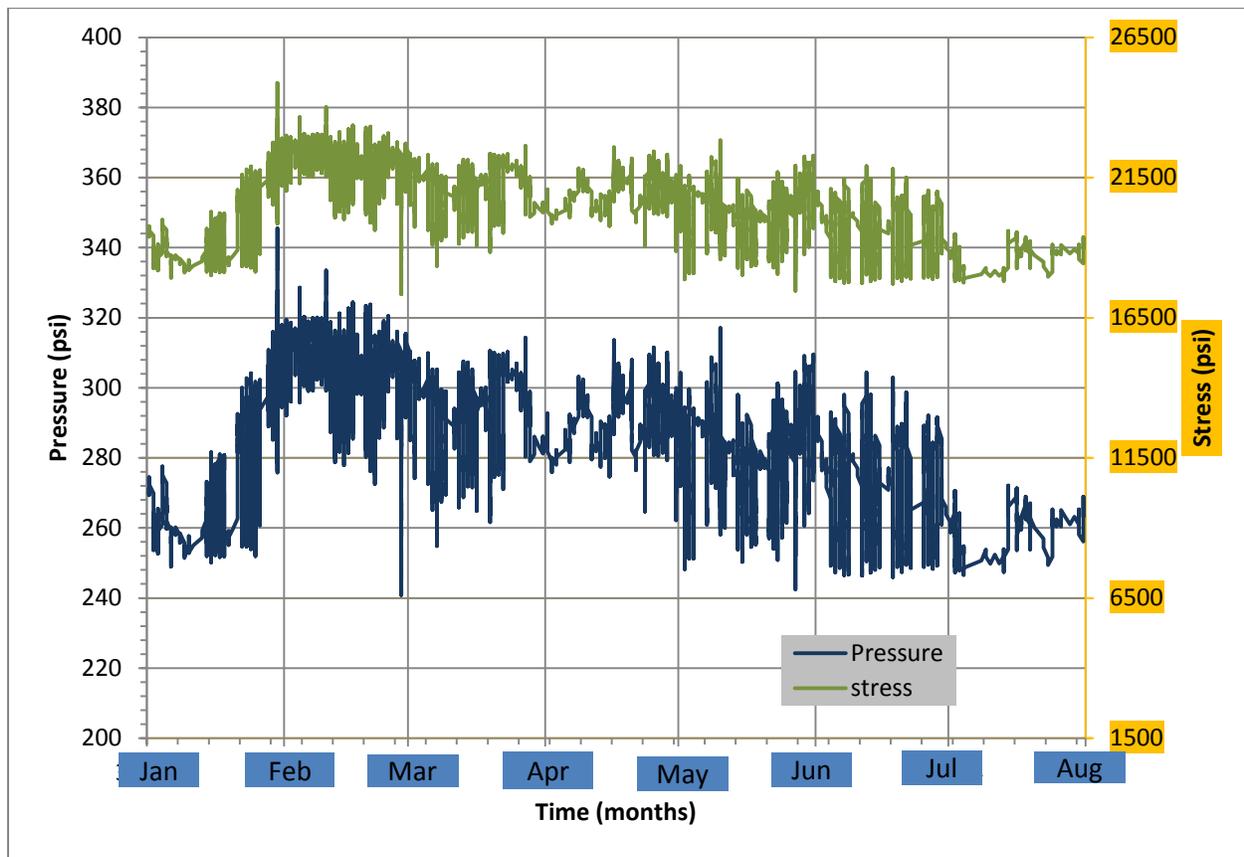
Pressure and Stress Data in 2007 near Rialto Feeder (Sta. 14+00) - Figure 1

The Etiwanda Pipeline provides State water via the Rialto Pipeline to the Etiwanda Power Plant which then flows into the Upper Feeder. The Etiwanda Power Plant is currently being used in the peaking mode to maximize power generation revenues. In order to maximize power generation revenues, the flow through the turbine is varied daily. During the day, the flow is maximized to increase the amount of power that can be generated. During the night, the flow is reduced producing less energy. The result of this high flow/low flow operation and accompanying friction loss is that the pressure in the pipeline varies significantly daily. As can be seen from the graph, the pressure near the Etiwanda Power Plant (see Figure 1) varies from 250 psi to 300 psi daily. The steel cylinder stress at this location varies from 20 ksi to 23 ksi daily. Near the Etiwanda pipeline turnout at Station 14+00 the pressure varies from 50 psi to 90 psi daily. The stress at this location varies from 8 ksi to 14 ksi.

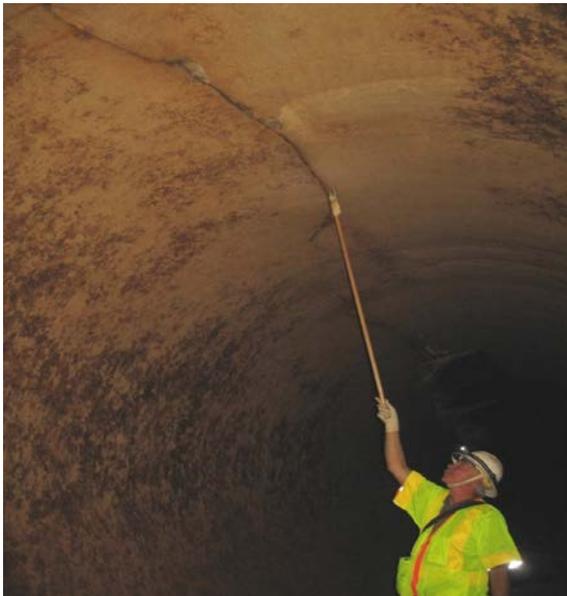
The third factor affecting the pipe is repeated cyclical loading. Although no literature was found on the effects of cyclical loading on mortar lining it is easy to see how this could severely affect the pipe lining. The cyclical loading is probably inhibiting the healing of the mortar lining.

This would eventually result in delamination of the mortar from the steel pipe. Once the lining is delaminated the mortar lining has to support itself as a concrete arch and failure is inevitable.

Failure Begins as Longitudinal Cracks Develop Along Crown of Pipe.

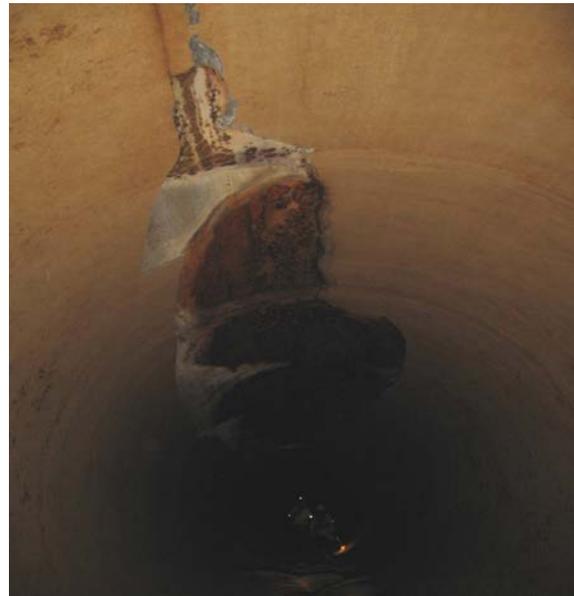
As Mortar Cracking Progresses Small Pieces of Mortar Fall Out of Crown of Pipe.

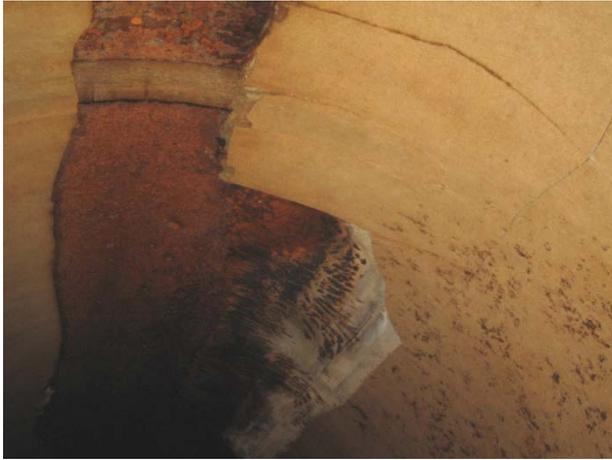
The final factor that may be affecting the pipe occurs after the mortar is delaminated from the pipe wall. It is possible that a differential pressure may develop between the water inside the pipe and the water behind the lining. If both the steel cylinder and the cylinder of mortar were completely disbonded, the expansion of the steel away from the mortar would occur at the crown of the pipe. Before the mortar fails it would remain in place only because it is supported by a combination of buoyancy and thin-shell arching. When the pipe is pressurized the radial expansion of the steel, (unconstrained by soil) would be $\delta = pr^2/Et$. This means that in an area where the pressure is 300 psi, the radial expansion would be $\delta = 0.050$ inch which cause a 0.10 inch (approximately 1/8 inch) gap between the steel and mortar. Because the mortar is porous, much like an open cell sponge, water between the mortar and steel cylinder would be expected to be at the same pressure as inside the lining. However if the pressure changes a differential pressure could develop for a short period of time. This differential pressure would cause additional cracks in the lining and accelerate the lining failure. After a sufficient number of cycles mortar pieces would begin to fail. This would cause adjacent sections mutually dependent upon the thin-shell arch for support to eventually fail.

Mortar Lining Failure Progresses After Initial Failure.

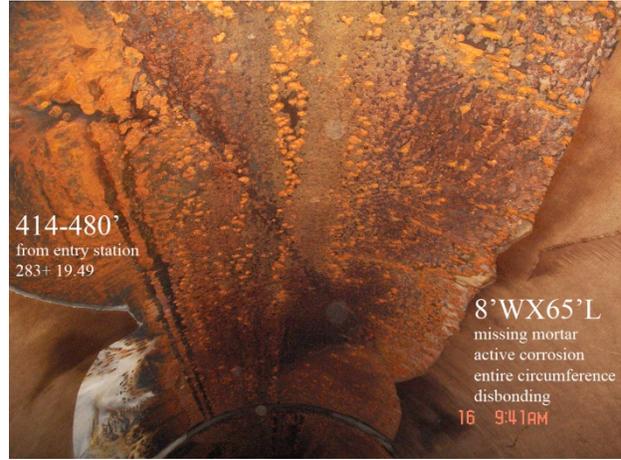
Exposed Steel Pipe is Unprotected and Begins to Corrode.

MWD is still evaluating how to repair the lining. Some of the options MWD is considering are mortar lining with welded wire fabric reinforcement and flexible coatings such as, high solids epoxy and polyurethane.
