## **Retrofit of CFRP Installation to Meet Current Design Standards**

Michael McReynolds, S.E, P.E.<sup>1</sup>, Bill Sleeper, PE<sup>2</sup>, and Mehdi S. Zarghamee, PhD P.E.<sup>3</sup>, Anna Pridmore, PhD<sup>4</sup>

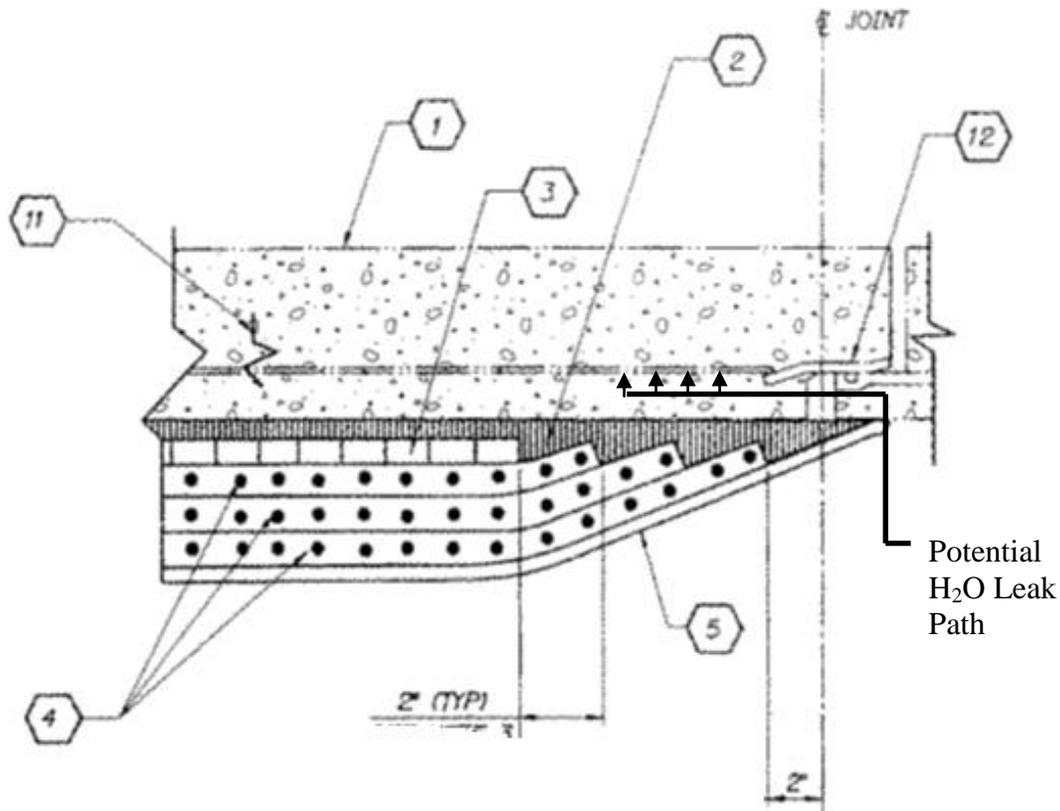
### Termination Detail in Original Design: Figure 1

During the original design, a hydrotest was not performed due to the cost of such a test. At the time of installation, the need to terminate the CFRP on the steel cylinder was not recognized. The CFRP was terminated on the surface of the PCCP. Subsequent testing performed by other agencies has shown that failure to attach the CFRP to the cylinder allows water to get behind the CFRP and can result in catastrophic failure of the PCCP. See Figure 1. This failure mechanism has been confirmed by Water Research Foundation (WRF) tests which show that the cylinder can fail due to water intrusion behind the CFRP lining at the joint. Over the last ten years the need for the CFRP to be terminated by attaching it to the steel cylinder has become the industry standard<sup>4</sup>.

MWD's original design also did not provide longitudinal CFRP to account for Poisson Ratio effect in the longitudinal direction. The only longitudinal reinforcing provided was from the Kevlar fill fibers used to hold the weave together. The Kevlar fill fibers have negligible reinforcement provided in comparison with the amount of reinforcement in the primary fiber direction and don't provide adequate longitudinal reinforcement. The current draft code<sup>4</sup> requires that longitudinal CFRP be provided to account for Poisson's Ratio, and temperature effects.

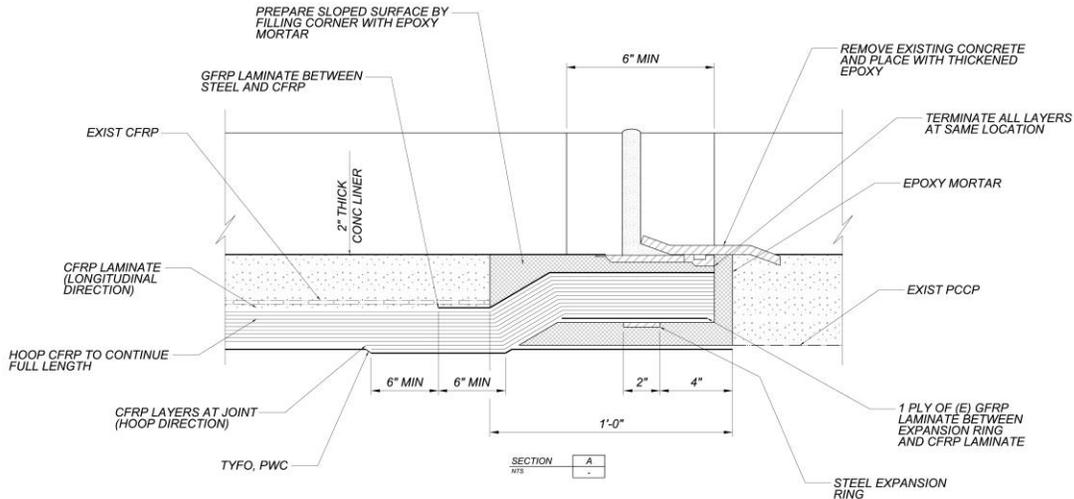
**Termination Detail in New Design: Figure 2**

MWD then evaluated the longitudinal strain and determined that the number of longitudinal layers required was at least 30% greater than the previously installed number of longitudinal layers. These new longitudinal layers were designed to resist temperature and Poisson's Ratio. MWD developed a new design detail to remove existing CFRP at the joint and install new longitudinal and hoop layers of CFRP attached to the cylinder at the bell or spigot. The detail is shown in Figure 2.

The repair consisted of cutting the CFRP and removing the mortar lining at the joint. The removal of the existing mortar and CFRP was performed using power-tooled equipment with a diamond blade. The material was easily removed and the cylinder exposed. The Contractor then brought the steel cylinder surface to white metal. Only light grinding was permitted; sand blasting was prohibited because of the risk of puncturing the cylinder. The PWC was roughened or removed. Then an epoxy mortar was installed to transition from the cylinder to the top of the existing CFRP. CFRP was then attached to the cylinder for 6 to 8 inches depending upon the development length required. The CFRP prevents a corrosion cell between the CFRP and the steel cylinder. Next the longitudinal layers of CFRP were installed over the entire length of the pipe including the portion with the CFRP. Following this, a minimum of one layer of CFRP was installed over the whole length of the pipe. This

final layer insured that if any of the existing CFRP damaged during the removal of the PWC by grinding was replaced with a new layer of CFRP. At the joint, multiple layers of CFRP were installed. The number of layers at the joint was based upon the buckling requirements. Finally the Tyfo PWC was installed over the top of the new CFRP. See Figure 2.

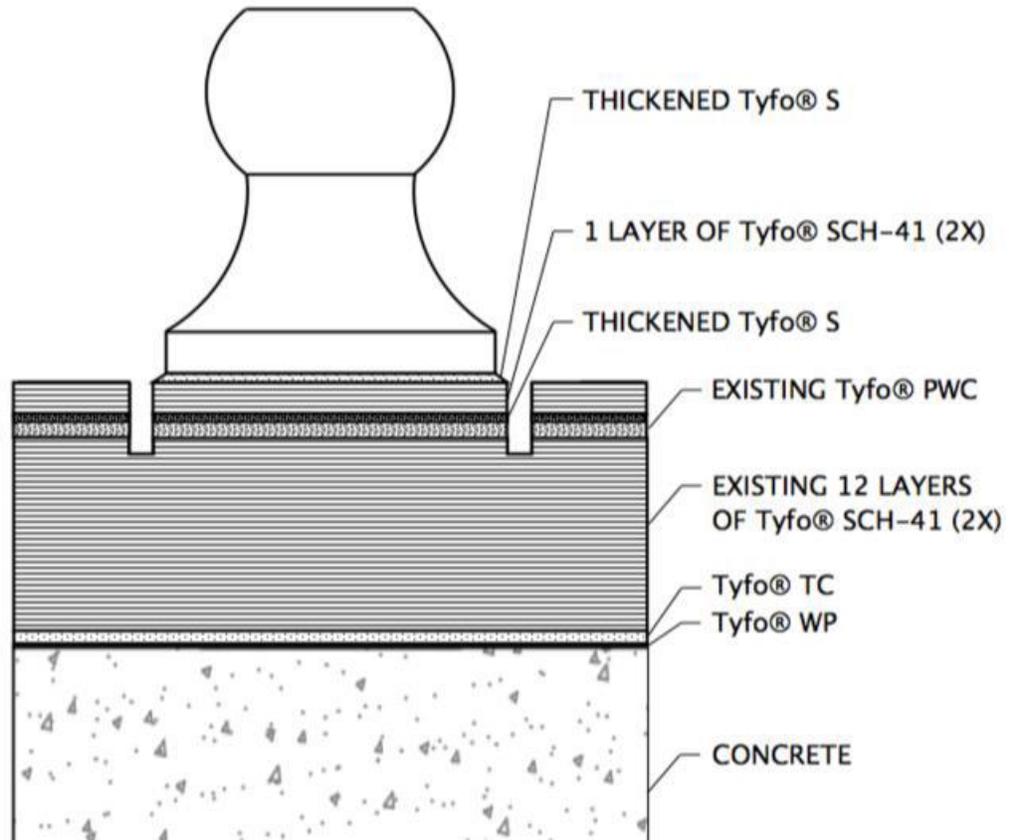
**Pull Test Assembly Detail: Figure 3**

In order to determine if the Tyfo PWC had to be removed entirely, several Direct Tension Pull-off tests were conducted in accordance with *ASTM D4541 Standard Test Method for Pull-Off Strength of Coatings Using Portable Adhesion Tester*<sup>5</sup>. The bond strength as well as the failure modes were recorded. These failure modes are described in Figure 3.

The pull tests were used to determine the amount of surface preparation required. In one study some of the samples had only the surface of the Tyfo PWC roughened with sandblasting (from 1% to 5% of the PWC coating removed). Other samples were sandblasted until 5% to 25% of the PWC was removed. One set of samples received aggressive grinding and this resulted in 30% to 80% of the PWC being removed. The pull test results can be seen in Table 3. The test results indicated that there was no significant difference between the various levels of surface preparation and the resulting bond strength.
